**Subject: Emergency Response Trip Report and Removal Site Evaluation
 Park Warehouse Fire Site, St. Louis, Missouri
 U.S. EPA Region 7 START 4, Contract No. EP-S7-13-06, Task Order No. 0203
 Task Monitor: Heath Smith, EPA On-Scene Coordinator**

**EMERGENCY RESPONSE TRIP REPORT AND REMOVAL SITE EVALUATION
PARK WAREHOUSE FIRE, ST. LOUIS, MISSOURI**

**Superfund Technical Assessment and Response Team (START) 4 Contract
Contract No. EP-S7-13-06, Task Order No. 0203**

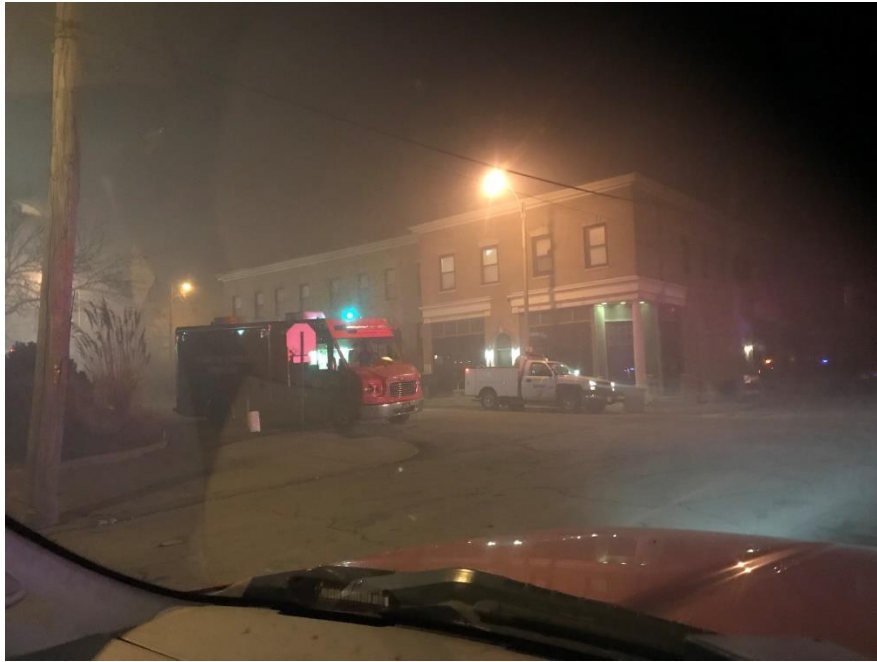
Photo No.: 3	Date: 11/15/2017	Time: 22:30
Photographer: Greg Blattner		Direction: Southeast
Latitude: 38.621460		Longitude: -90.244454
Description: This photograph shows the St. Louis Fire Department Mobile Command Post.

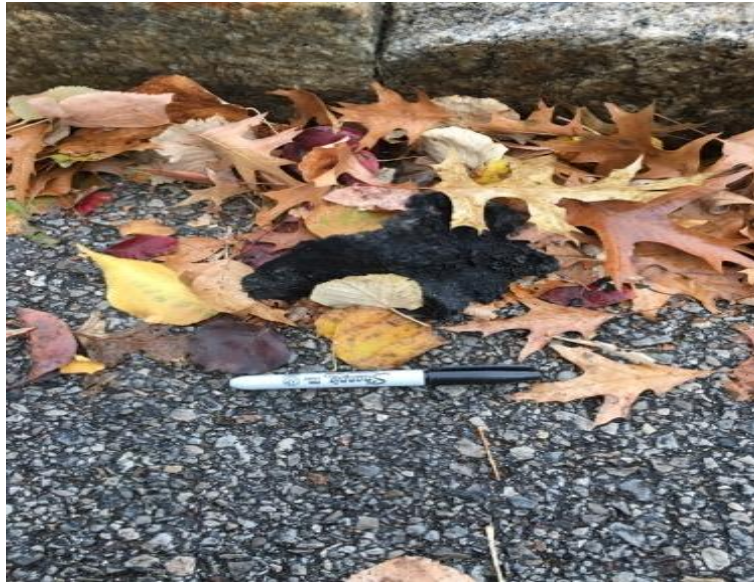
Photo No.: 9	Date: 11/18/2017	Time: 07:49
Photographer: Heath Smith		Direction: North
Latitude: 38.619590		Longitude: -90.244997
Description: This photograph shows debris sample WF-T2-001 collected from residential neighborhood near Park Warehouse..

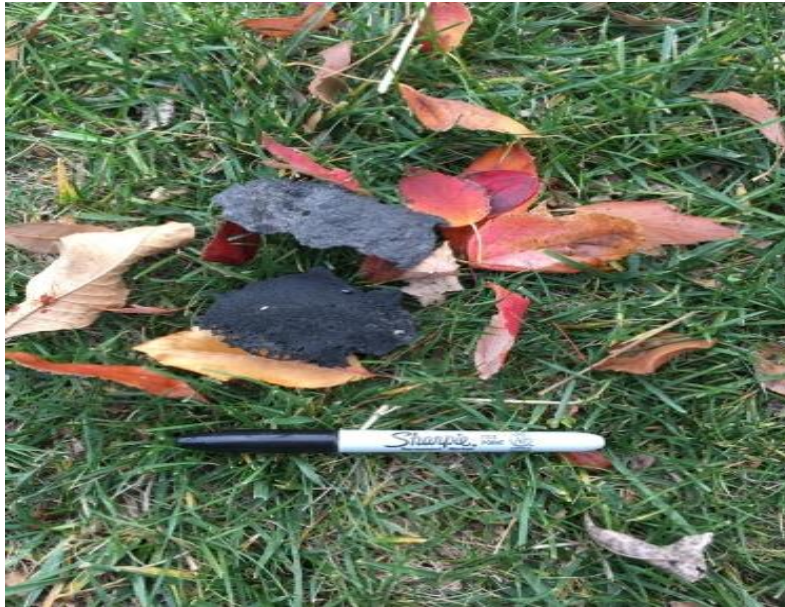
Photo No.: 11	Date: 11/18/2017	Time: 08:04
Photographer: Heath Smith		Direction: East
Latitude: 38.619646		Longitude: -90.244573
Description: This photograph shows debris sample WF-T2-003 collected from residential neighborhood near Park Warehouse.

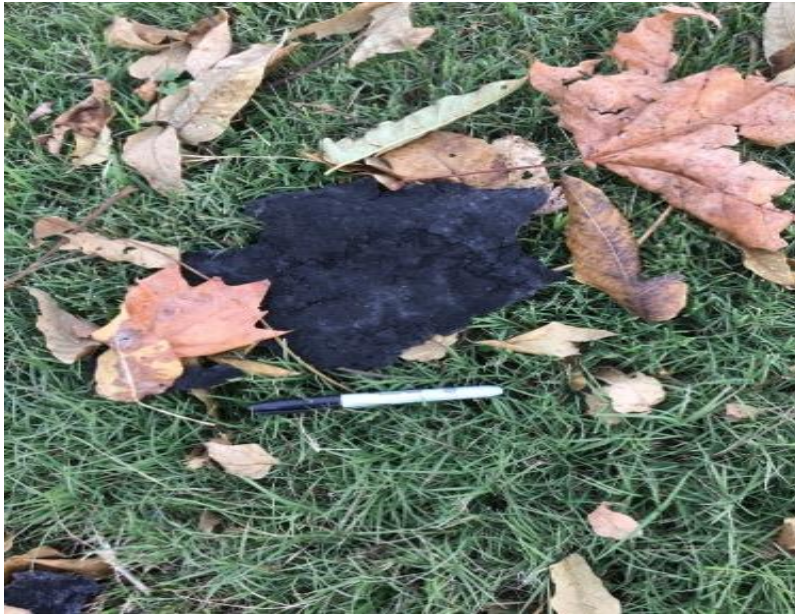
Photo No.: 15	Date: 11/18/2017	Time: 08:29
Photographer: Heath Smith		Direction: North
Latitude: 38.620500		Longitude: -90.244431
Description: This photograph shows debris sample WF-T2-007 collected from residential neighborhood near Park Warehouse.

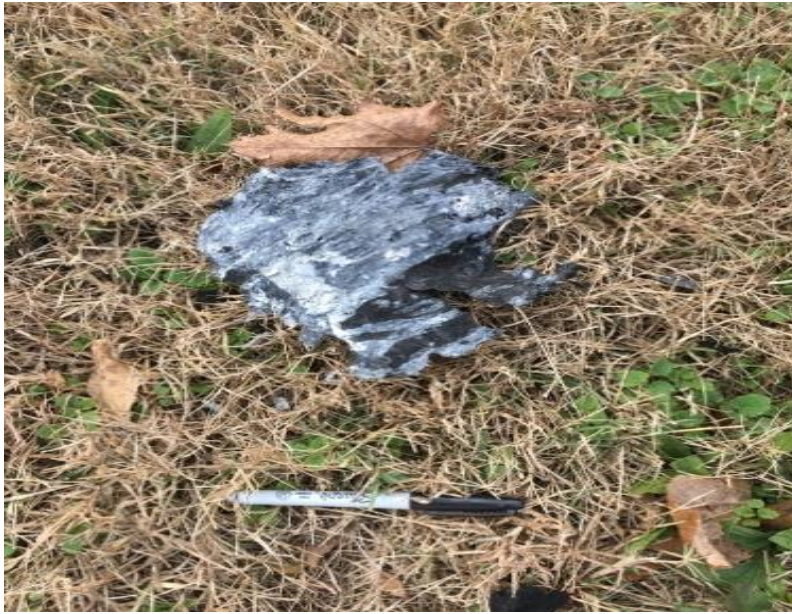
Photo No.: 17	Date: 11/18/2017	Time: 08:34
Photographer: Heath Smith		Direction: Southeast
Latitude: 38.620630		Longitude: -90.244394
Description: This photograph shows debris sample WF-T2-009 collected from residential neighborhood near Park Warehouse.

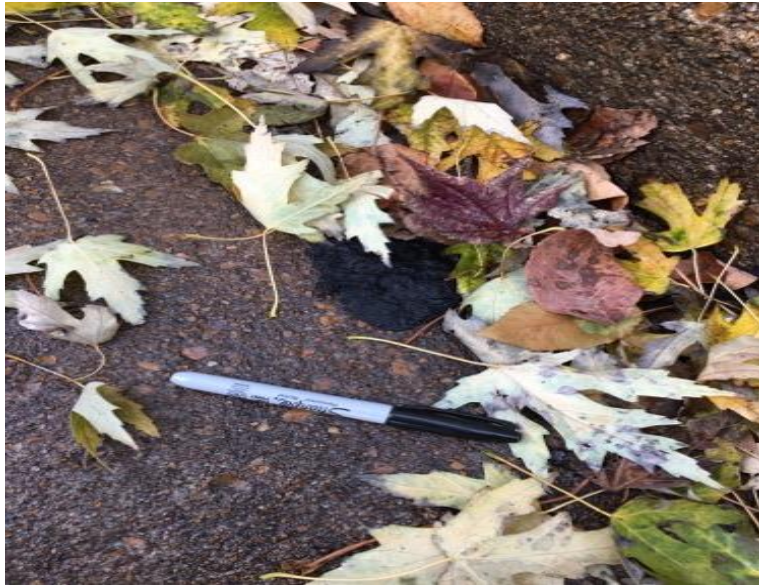
Photo No.: 19	Date: 11/18/2017	Time: 09:13
Photographer: Heath Smith		Direction: Southeast
Latitude: 38.619139		Longitude: -90.241893
Description: This photograph shows debris sample WF-T2-011 collected from residential neighborhood near Park Warehouse.

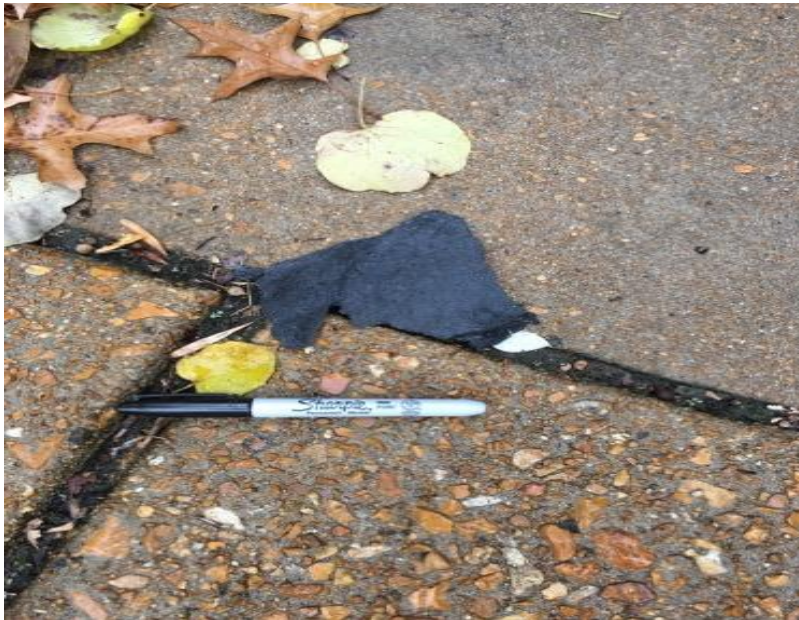
Photo No.: 22	Date: 11/18/2017	Time: 09:22
Photographer: Heath Smith		Direction: North
Latitude: 38.619289		Longitude: -90.240951
Description: This photograph shows debris sample WF-T2-014 collected from residential neighborhood near Park Warehouse.

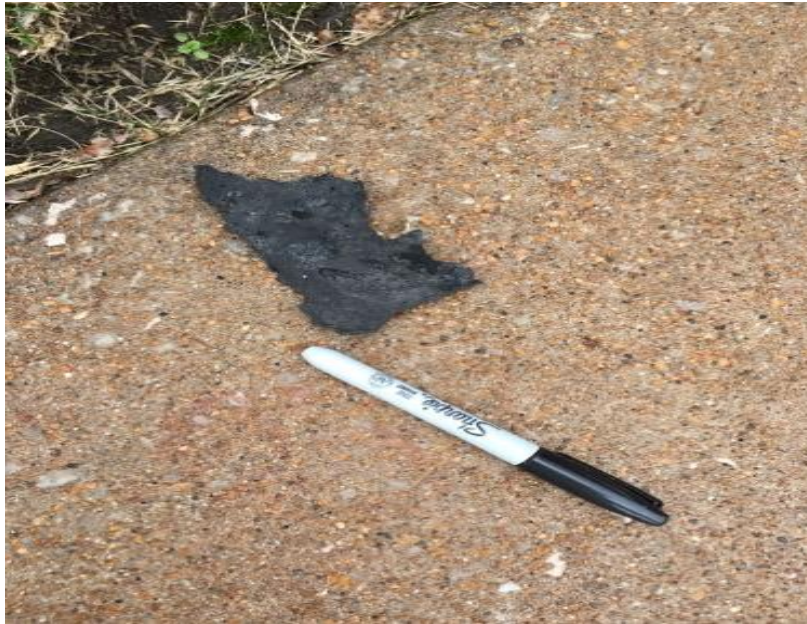
Photo No.: 23	Date: 11/18/2017	Time: 09:28
Photographer: Heath Smith		Direction: West
Latitude: 38.619014		Longitude: -90.239905
Description: This photograph shows debris sample WF-T2-015 collected from residential neighborhood near Park Warehouse.

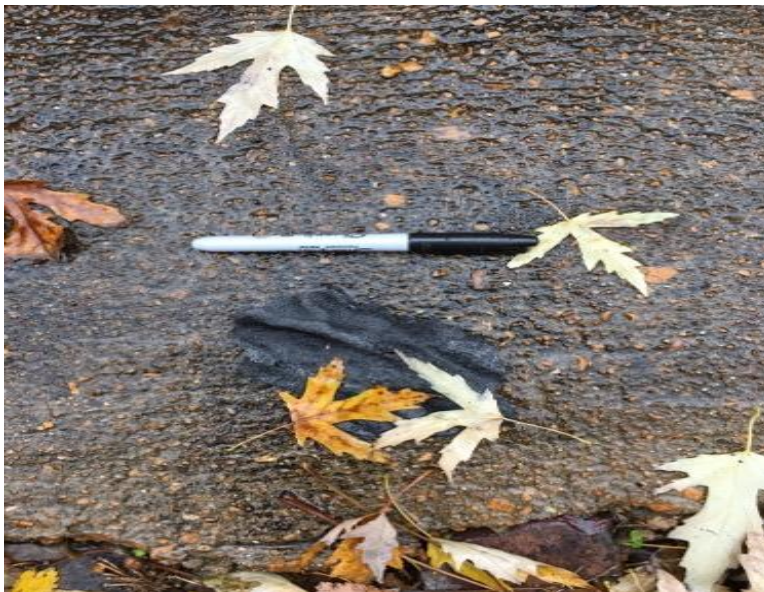
Photo No.: 26	Date: 11/18/2017	Time: 10:13
Photographer: Heath Smith		Direction: North
Latitude: 38.617817		Longitude: -90.241886
Description: This photograph shows debris sample WF-T2-018 collected from residential neighborhood near Park Warehouse.

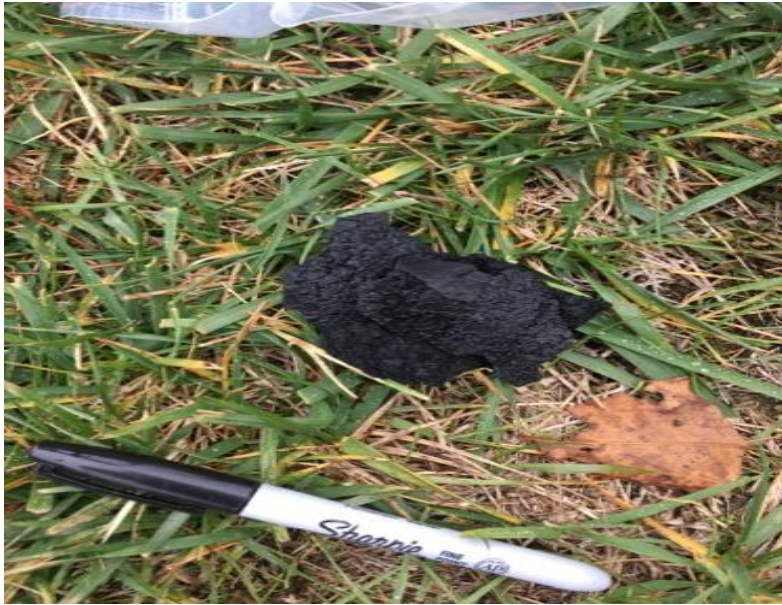
Photo No.: 27	Date: 11/18/2017	Time: 10:49
Photographer: Heath Smith		Direction: South
Latitude: 38.619065		Longitude: -90.245019
Description: This photograph shows debris sample WF-T2-019 collected from residential neighborhood near Park Warehouse.

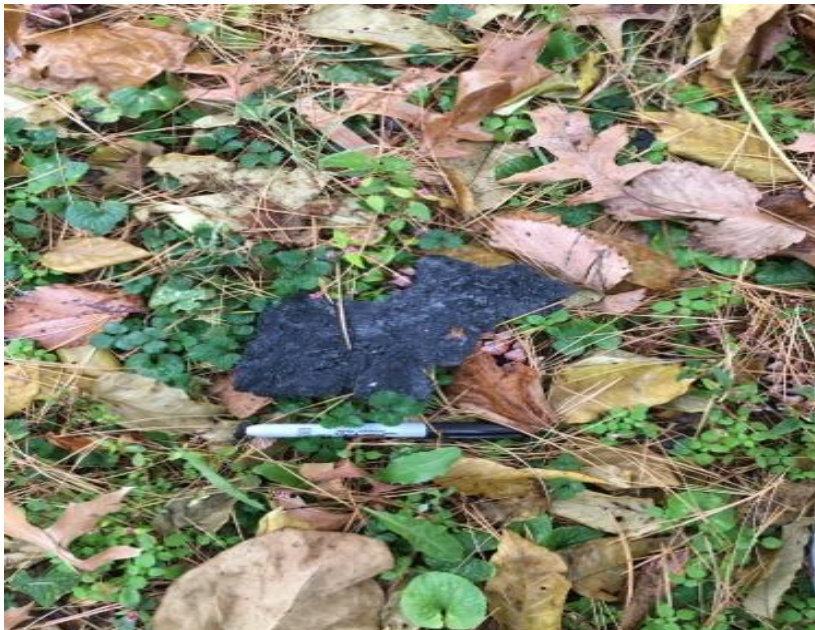
Photo No.: 32	Date: 11/18/2017	Time: 11:05
Photographer: Heath Smith		Direction: East
Latitude: 38.618965		Longitude: -90.242477
Description: This photograph shows debris sample WF-T2-024 collected from residential neighborhood near Park Warehouse.

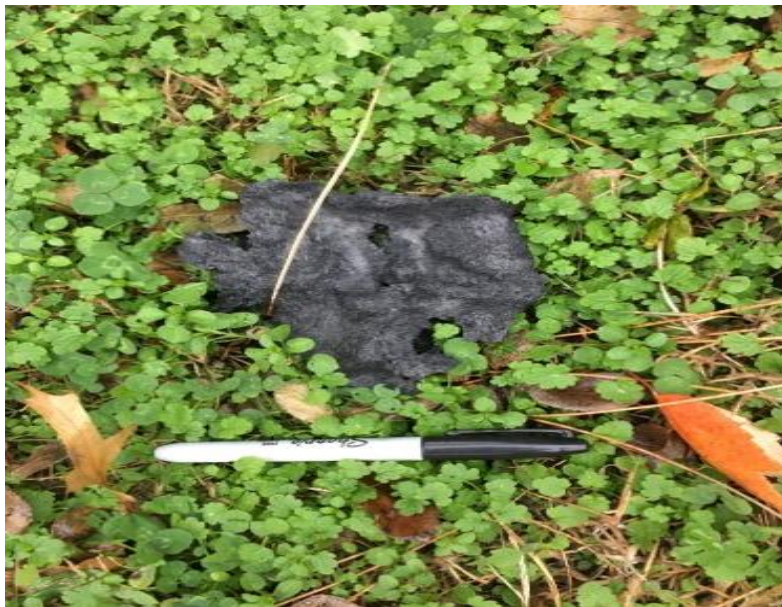
Photo No.: 34	Date: 11/18/2017	Time: 11:11
Photographer: Heath Smith		Direction: West
Latitude: 38.618937	Longitude: -90.242270	
Description: This photograph shows debris sample WF-T2-026 collected from residential neighborhood near Park Warehouse.

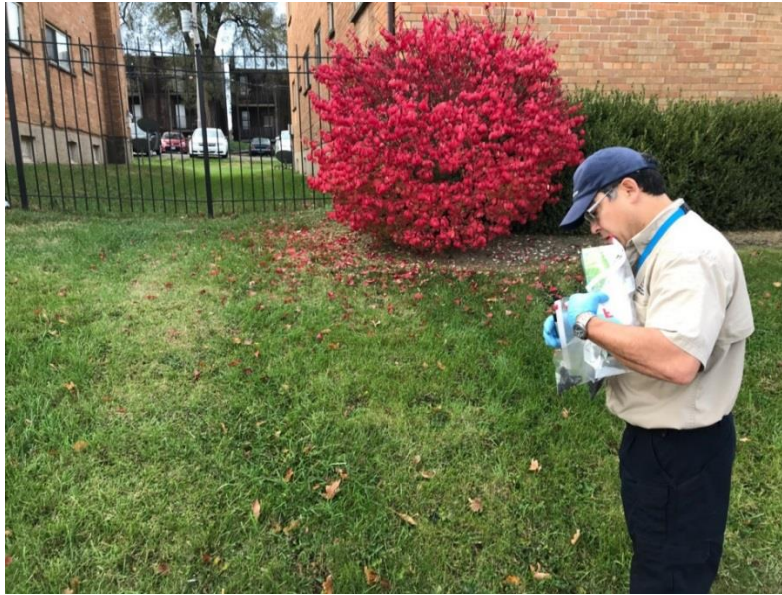
Photo No.: 37	Date: 11/18/2017	Time: 08:10
Photographer: Greg Blattner		Direction: South
Latitude: 38.62118		Longitude: -90.24360
Description: This photograph shows debris sample WF-T1-003 collected from residential neighborhood near Park Warehouse.

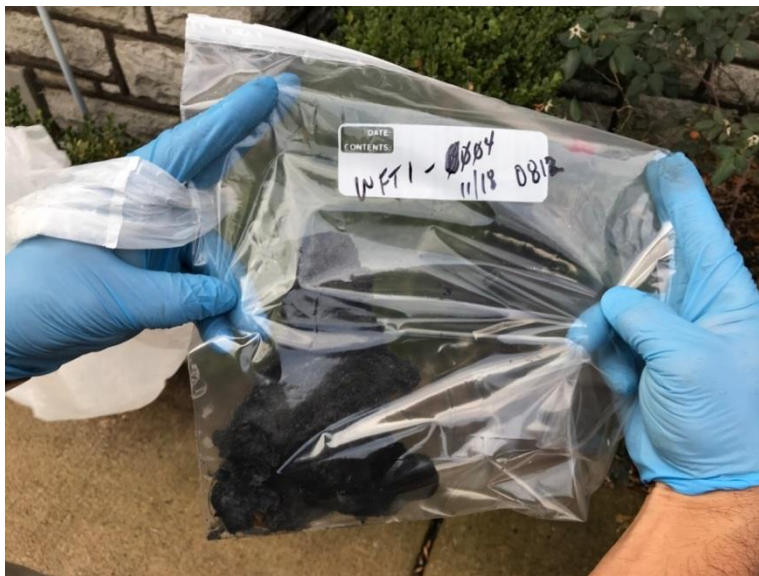
Photo No.: 40	Date: 11/18/2017	Time: 08:12
Photographer: Greg Blattner		Direction: South
Latitude: 38.62115		Longitude: -90.24324
Description: This photograph shows debris sample WF-T1-004 collected from residential neighborhood near Park Warehouse.

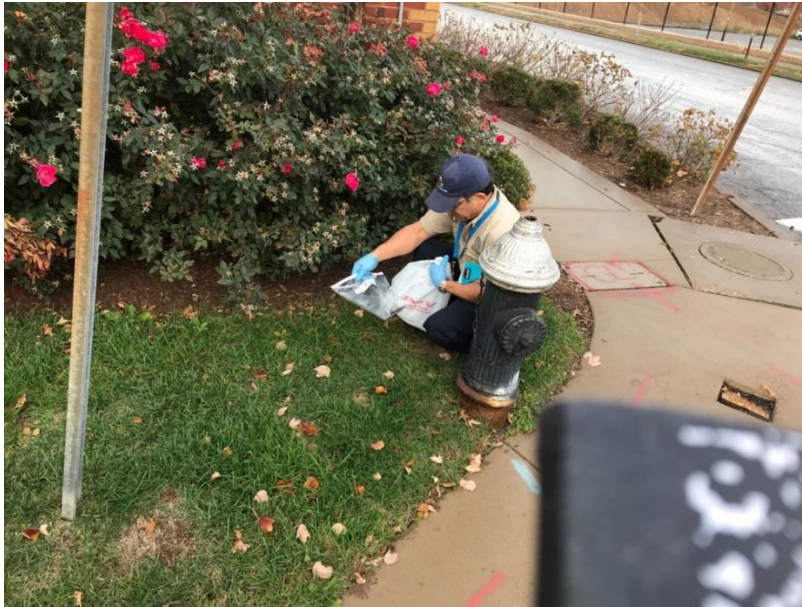
Photo No.: 41	Date: 11/18/2017	Time: 08:15
Photographer: Greg Blattner		Direction: West
Latitude: 38.62091		Longitude: -90.24187
Description: This photograph shows debris sample WF-T1-005 collected from residential neighborhood near Park Warehouse.

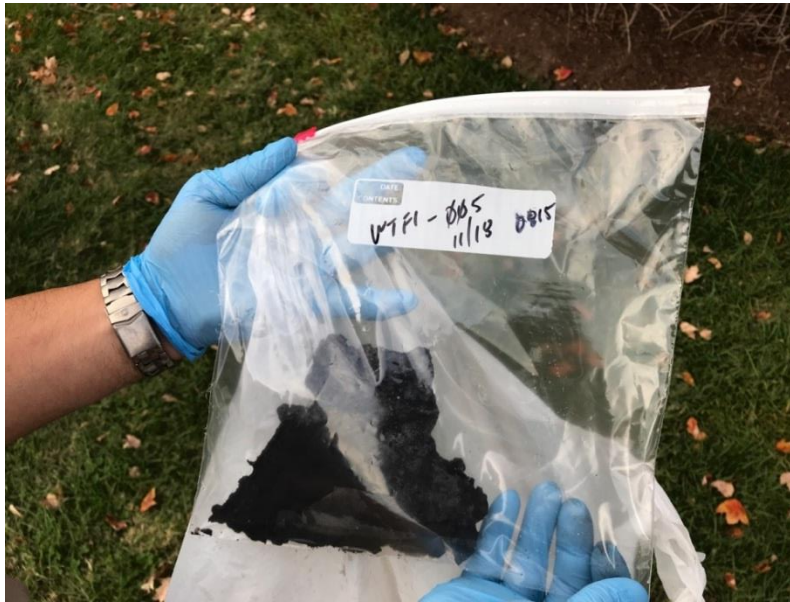
Photo No.: 42	Date: 11/18/2017	Time: 08:15
Photographer: Greg Blattner		Direction: West
Latitude: 38.62091		Longitude: -90.24187
Description: This photograph shows debris sample WF-T1-005 collected from residential neighborhood near Park Warehouse.

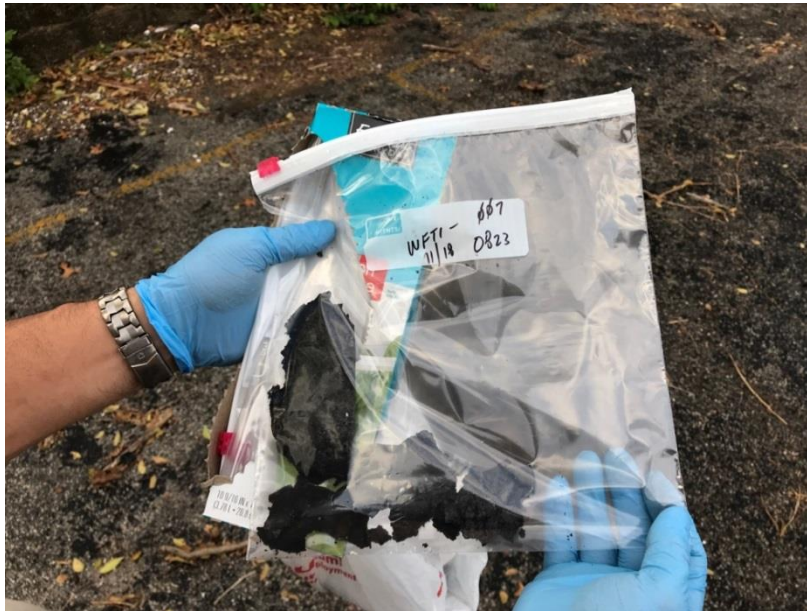
Photo No.: 46	Date: 11/18/2017	Time: 08:23
Photographer: Greg Blattner		Direction: North
Latitude: 38.62060	Longitude: -90.24233	
Description: This photograph shows debris sample WF-T1-007 collected from residential neighborhood near Park Warehouse.

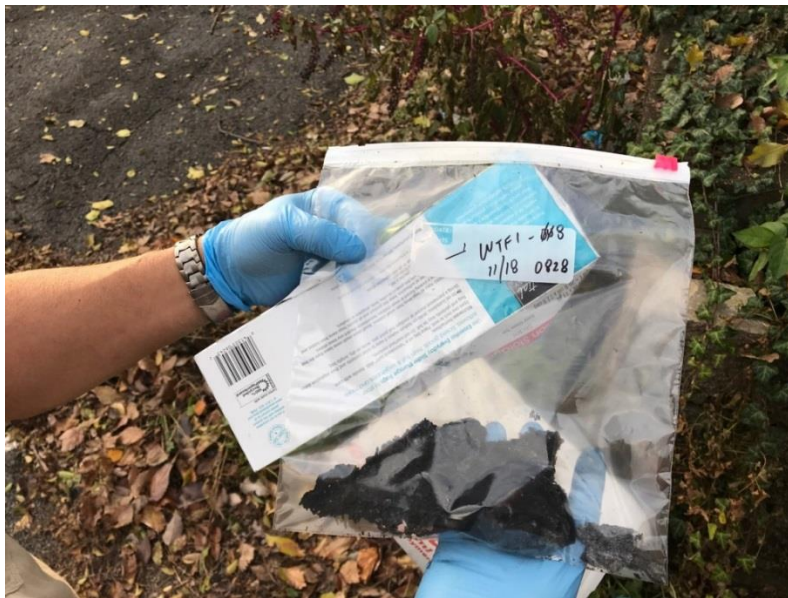
Photo No.: 48	Date: 11/18/2017	Time: 08:28
Photographer: Greg Blattner		Direction: North
Latitude: 38.62073		Longitude: -90.24297
Description: This photograph shows debris sample WF-T1-008 collected from residential neighborhood near Park Warehouse.

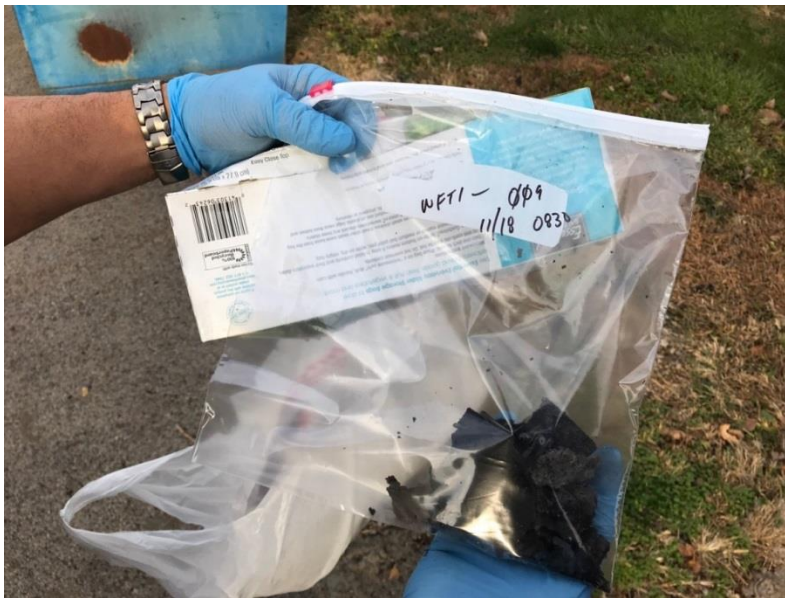
Photo No.: 50	Date: 11/18/2017	Time: 08:30
Photographer: Greg Blattner		Direction: Northwest
Latitude: 38.62081		Longitude: -90.24338
Description: This photograph shows debris sample WF-T1-009 collected from residential neighborhood near Park Warehouse.

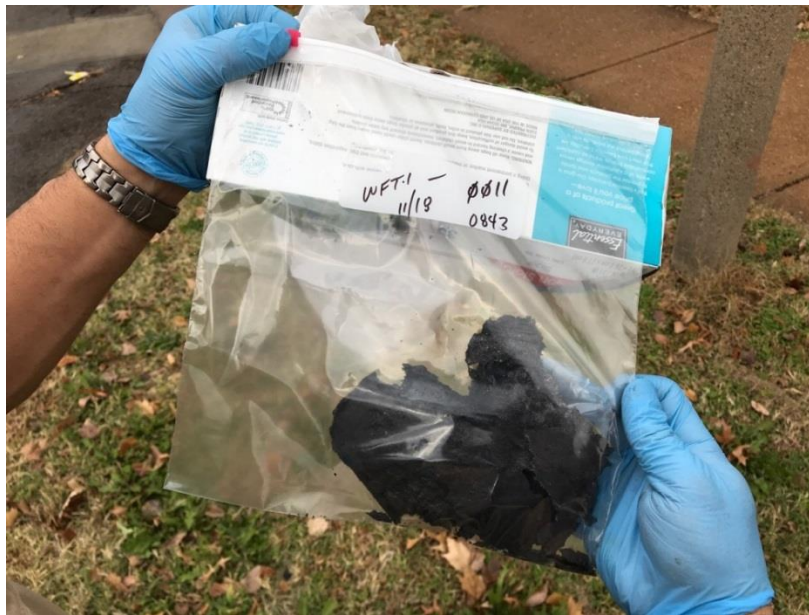
Photo No.: 54	Date: 11/18/2017	Time: 08:43
Photographer: Greg Blattner		Direction: North
Latitude: 38.62026	Longitude: -90.24213	
Description: This photograph shows debris sample WF-T1-011 collected from residential neighborhood near Park Warehouse.

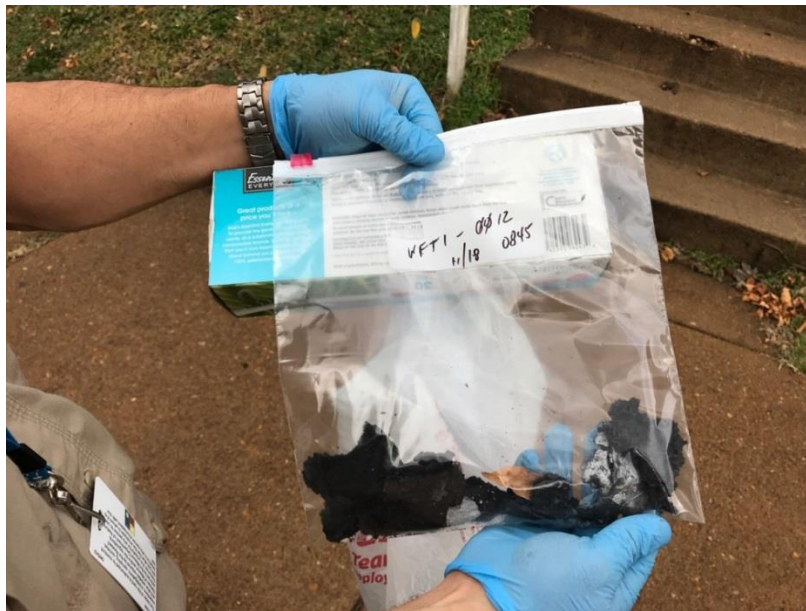
Photo No.: 56	Date: 11/18/2017	Time: 08:45
Photographer: Greg Blattner		Direction: Northwest
Latitude: 38.62028	Longitude: -90.24234	
Description: This photograph shows debris sample WF-T1-012 collected from residential neighborhood near Park Warehouse.

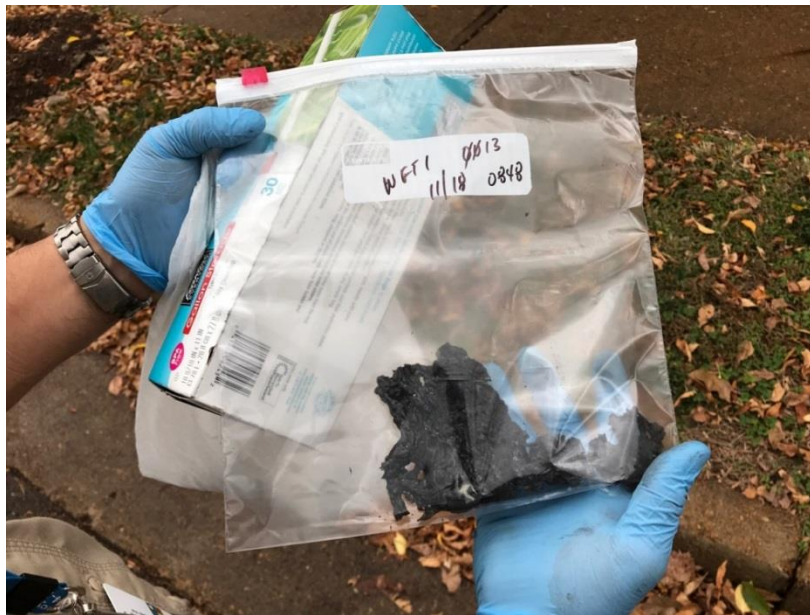
Photo No.: 58	Date: 11/18/2017	Time: 08:48
Photographer: Greg Blattner		Direction: Northwest
Latitude: 38.62032	Longitude: -90.24269	
Description: This photograph shows debris sample WF-T1-013 collected from residential neighborhood near Park Warehouse.

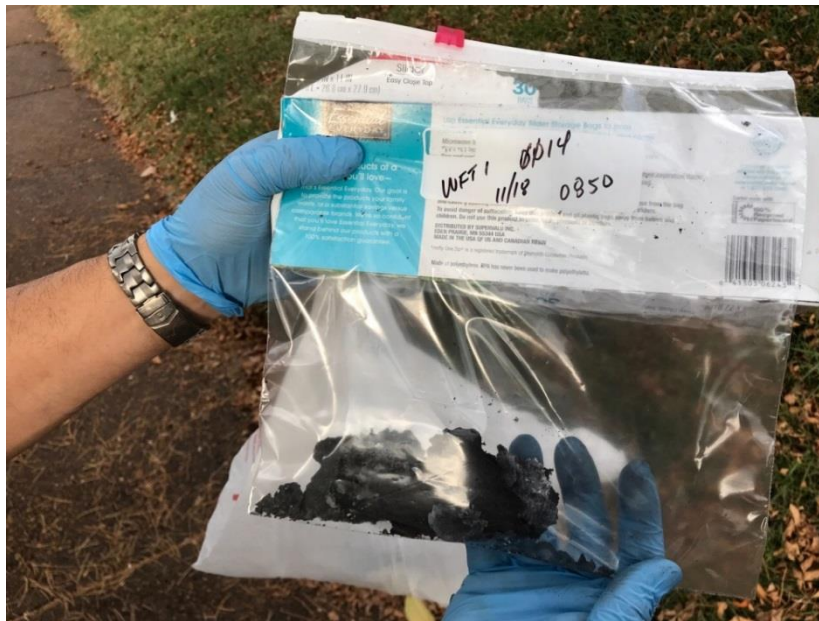
Photo No.: 60	Date: 11/18/2017	Time: 08:50
Photographer: Greg Blattner		Direction: West
Latitude: 38.62040	Longitude: -90.24338	
Description: This photograph shows debris sample WF-T1-014 collected from residential neighborhood near Park Warehouse.

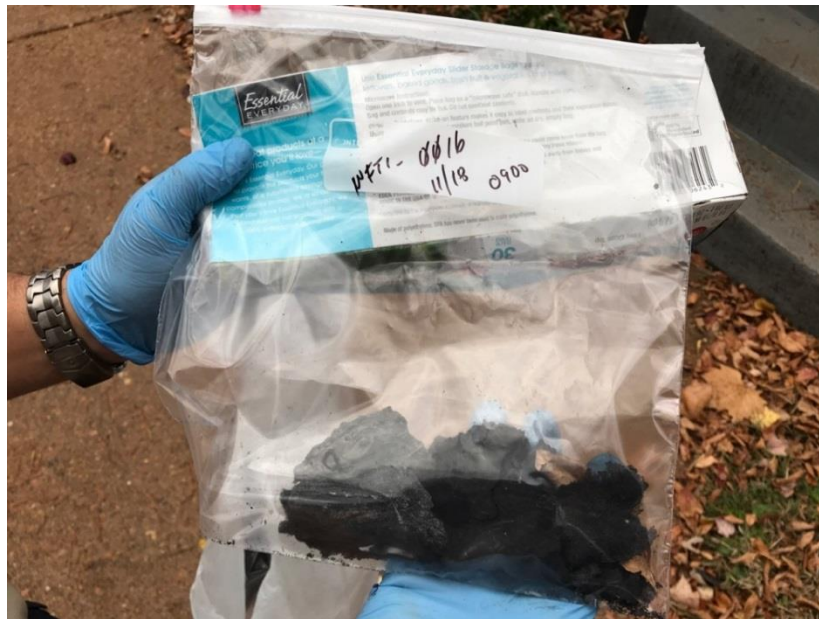
Photo No.: 64	Date: 11/18/2017	Time: 09:00
Photographer: Greg Blattner		Direction: East
Latitude: 38.62029		Longitude: -90.24424
Description: This photograph shows debris sample WF-T1-016 collected from residential neighborhood near Park Warehouse.

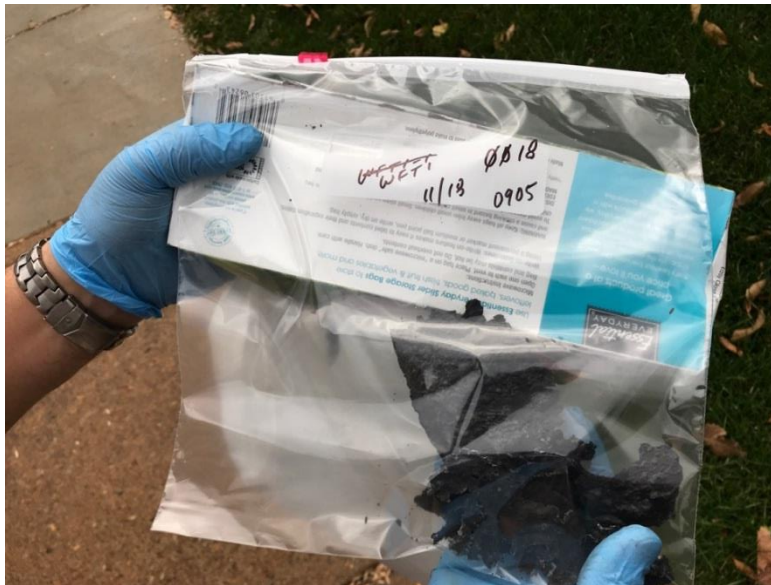
Photo No.: 68	Date: 11/18/2017	Time: 09:05
Photographer: Greg Blattner		Direction: East
Latitude: 38.62020	Longitude: -90.24311	
Description: This photograph shows debris sample WF-T1-018 collected from residential neighborhood near Park Warehouse.

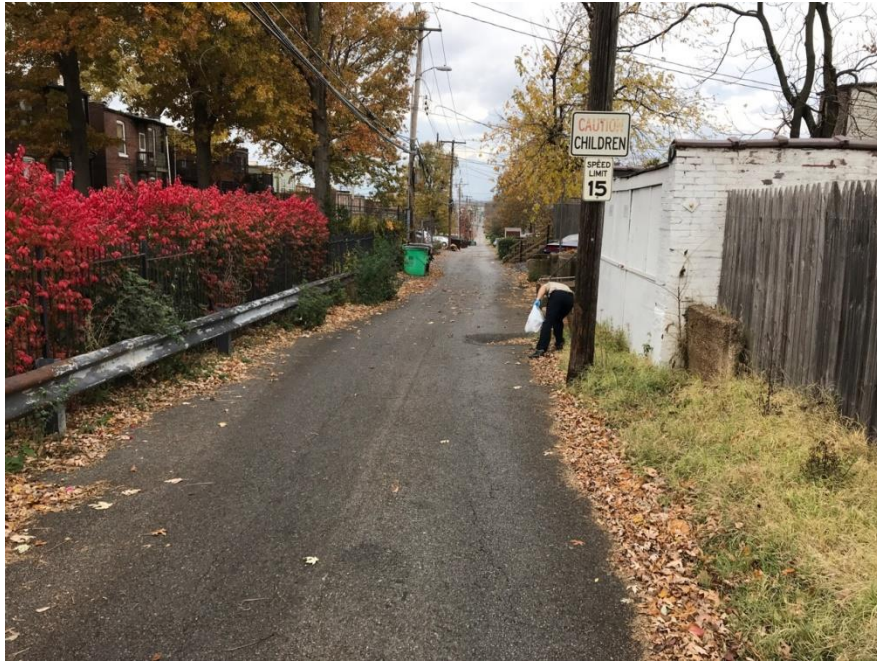
Photo No.: 73	Date: 11/18/2017	Time: 09:20
Photographer: Greg Blattner		Direction: West
Latitude: 38.61976		Longitude: -90.24222
Description: This photograph shows debris sample WF-T1-021 collected from residential neighborhood near Park Warehouse.

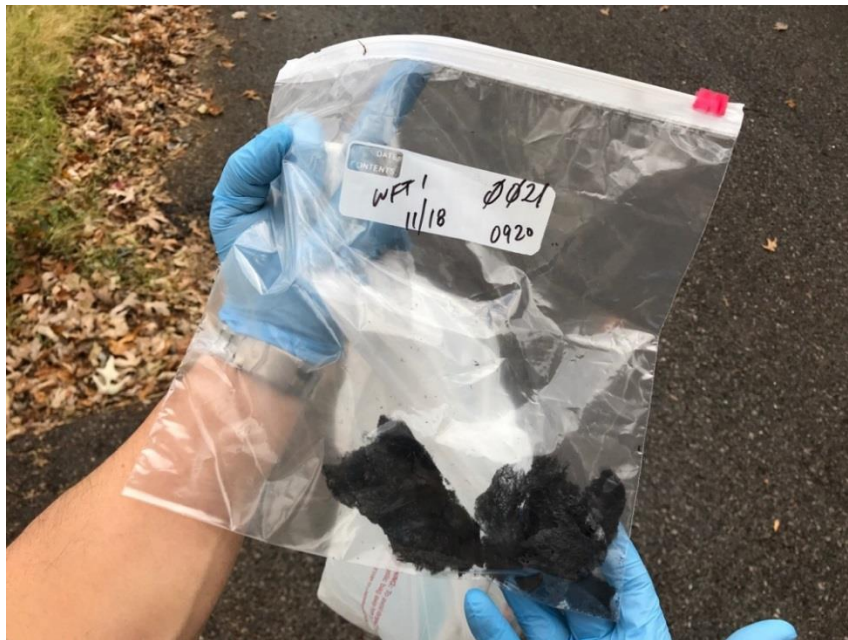
Photo No.: 74	Date: 11/18/2017	Time: 09:20
Photographer: Greg Blattner		Direction: West
Latitude: 38.61976		Longitude: -90.24222
Description: This photograph shows debris sample WF-T1-021 collected from residential neighborhood near Park Warehouse.

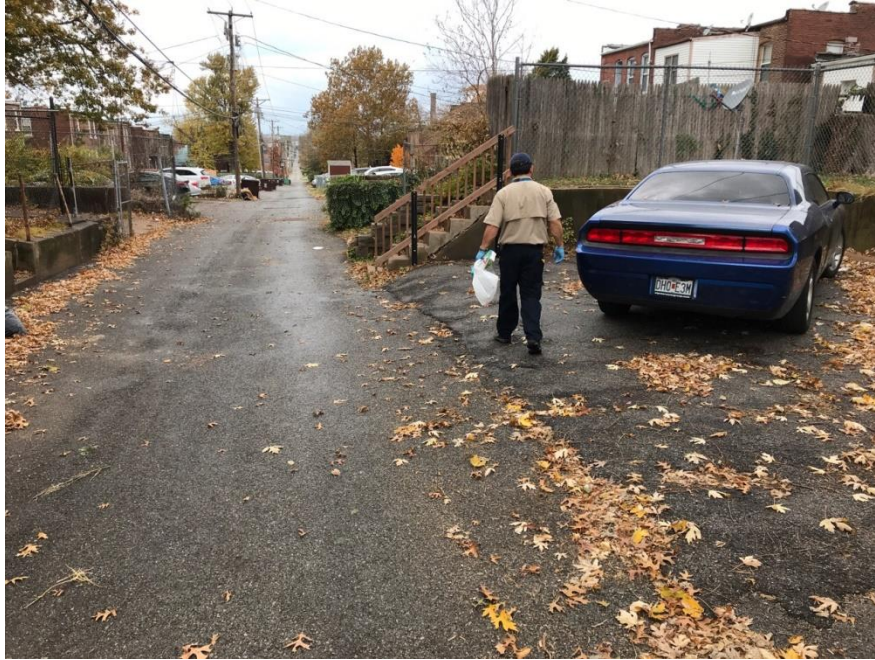
Photo No.: 75	Date: 11/18/2017	Time: 09:25
Photographer: Greg Blattner		Direction: West
Latitude: 38.61979		Longitude: -90.24252
Description: This photograph shows debris sample WF-T1-022 collected from residential neighborhood near Park Warehouse.

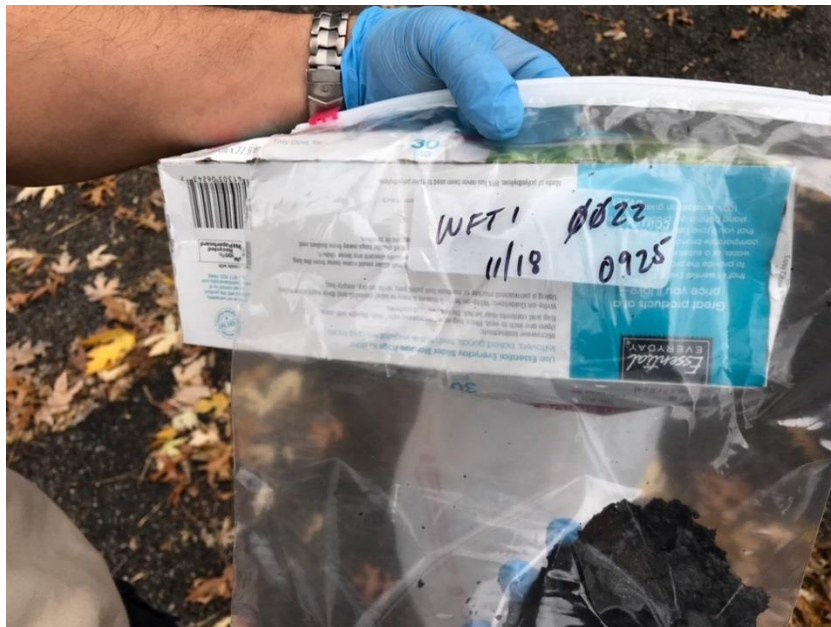
Photo No.: 76	Date: 11/18/2017	Time: 09:25
Photographer: Greg Blattner		Direction: West
Latitude: 38.61979	Longitude: -90.24237	
Description: This photograph shows debris sample WF-T1-022 collected from residential neighborhood near Park Warehouse.

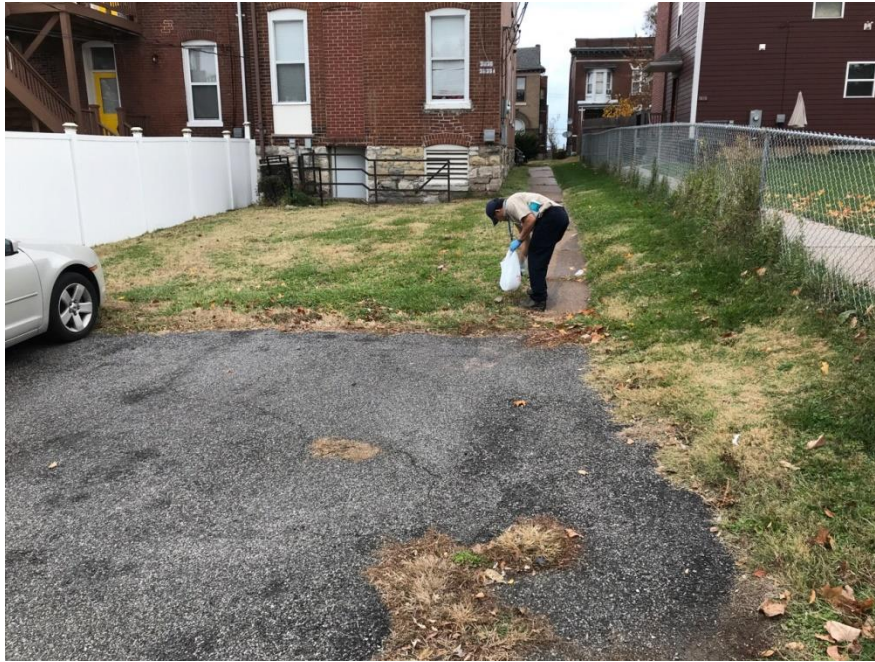
Photo No.: 77	Date: 11/18/2017	Time: 09:30
Photographer: Greg Blattner		Direction: North
Latitude: 38.61990		Longitude: -90.24335
Description: This photograph shows debris sample WF-T1-023 collected from residential neighborhood near Park Warehouse.

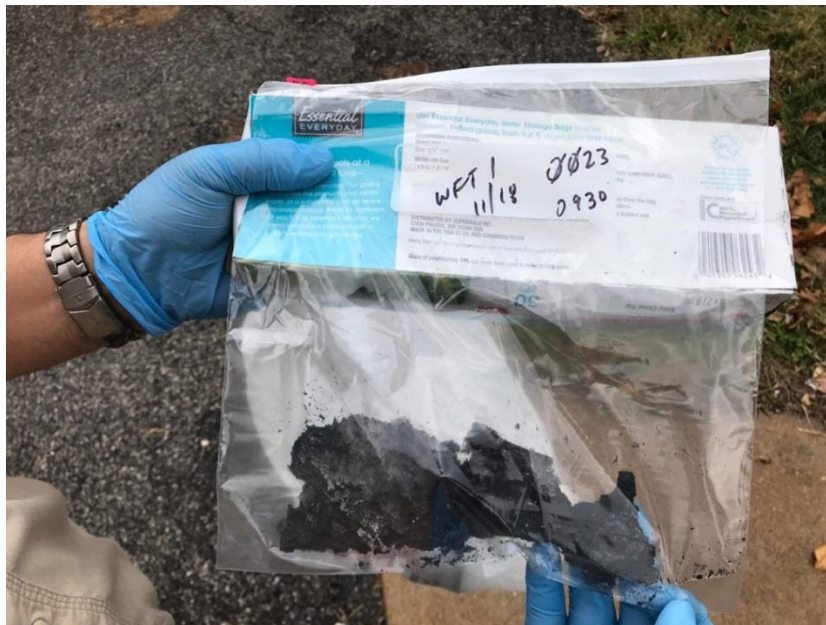
Photo No.: 78	Date: 11/18/2017	Time: 09:30
Photographer: Greg Blattner		Direction: North
Latitude: 38.61990	Longitude: -90.24335	
Description: This photograph shows debris sample WF-T1-023 collected from residential neighborhood near Park Warehouse.

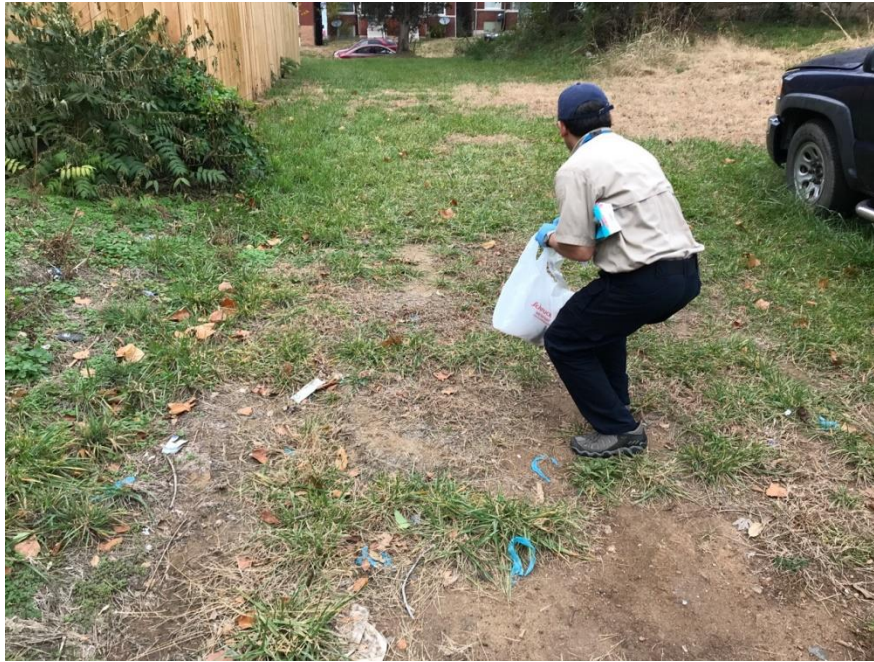
Photo No.: 79	Date: 11/18/2017	Time: 09:35
Photographer: Greg Blattner		Direction: North
Latitude: 38.61990		Longitude: -90.24369
Description: This photograph shows debris sample WF-T1-024 collected from residential neighborhood near Park Warehouse.

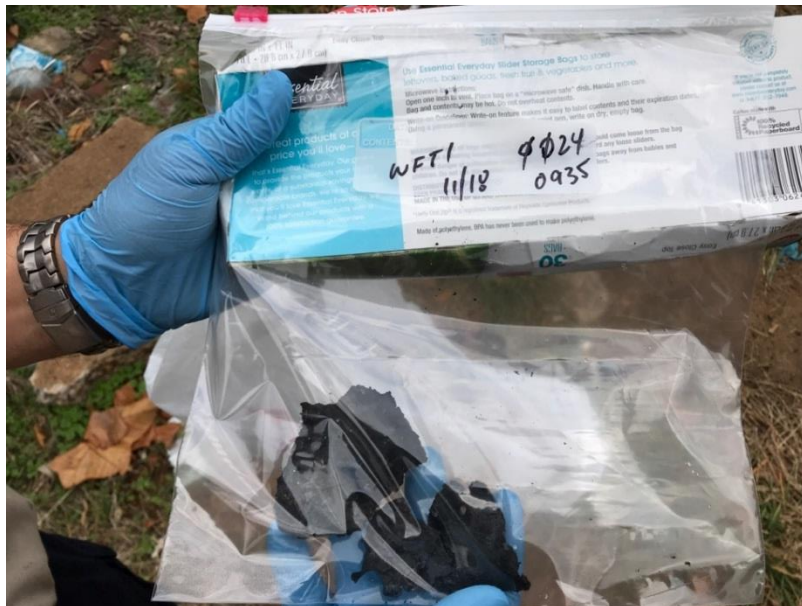
Photo No.: 80	Date: 11/18/2017	Time: 09:35
Photographer: Greg Blattner		Direction: North
Latitude: 38.61990		Longitude: -90.24369
Description: This photograph shows debris sample WF-T1-024 collected from residential neighborhood near Park Warehouse.

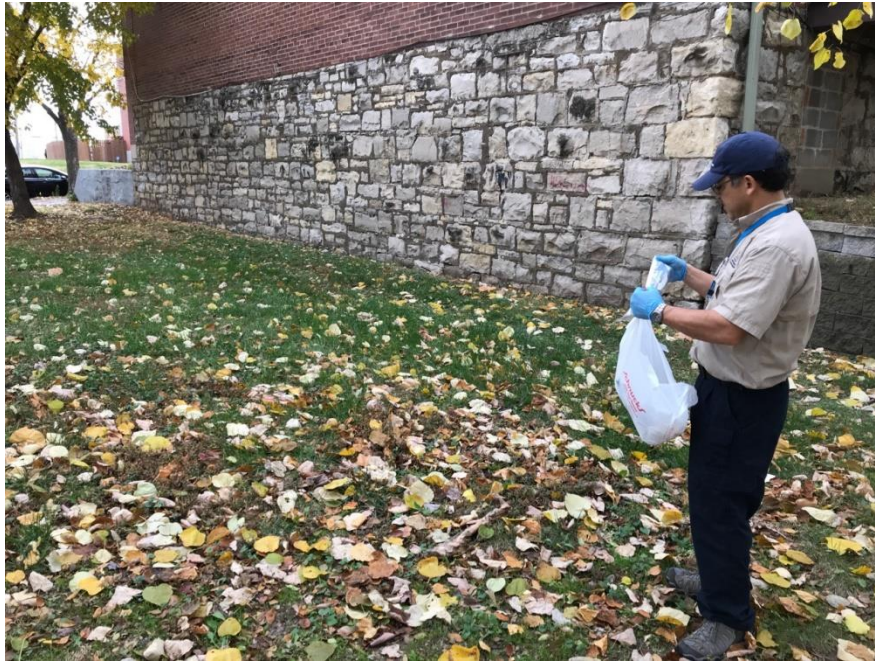
Photo No.: 81	Date: 11/18/2017	Time: 09:38
Photographer: Greg Blattner		Direction: North
Latitude: 38.62009		Longitude: -90.24432
Description: This photograph shows debris sample WF-T1-025 collected from residential neighborhood near Park Warehouse.

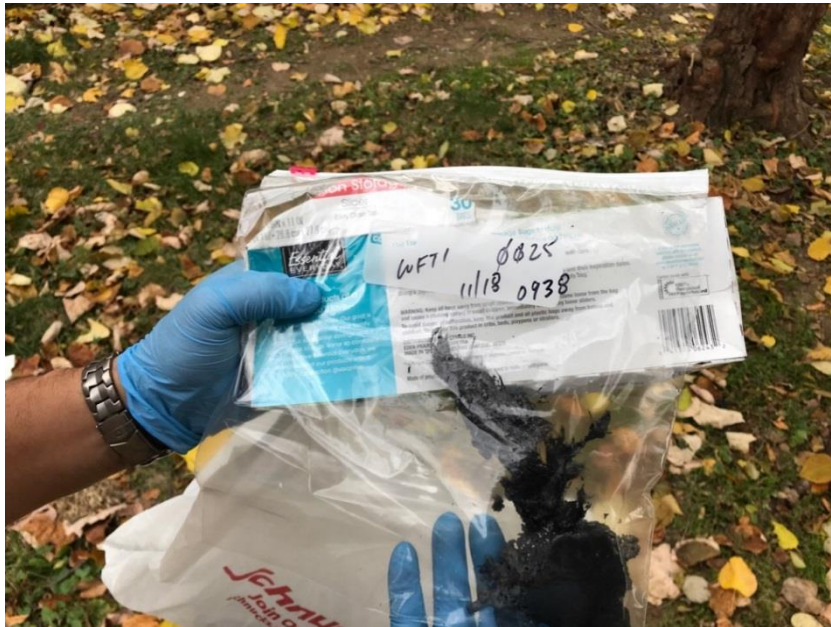
Photo No.: 82	Date: 11/18/2017	Time: 09:38
Photographer: Greg Blattner		Direction: North
Latitude: 38.62009		Longitude: -90.24432
Description: This photograph shows debris sample WF-T1-025 collected from residential neighborhood near Park Warehouse.

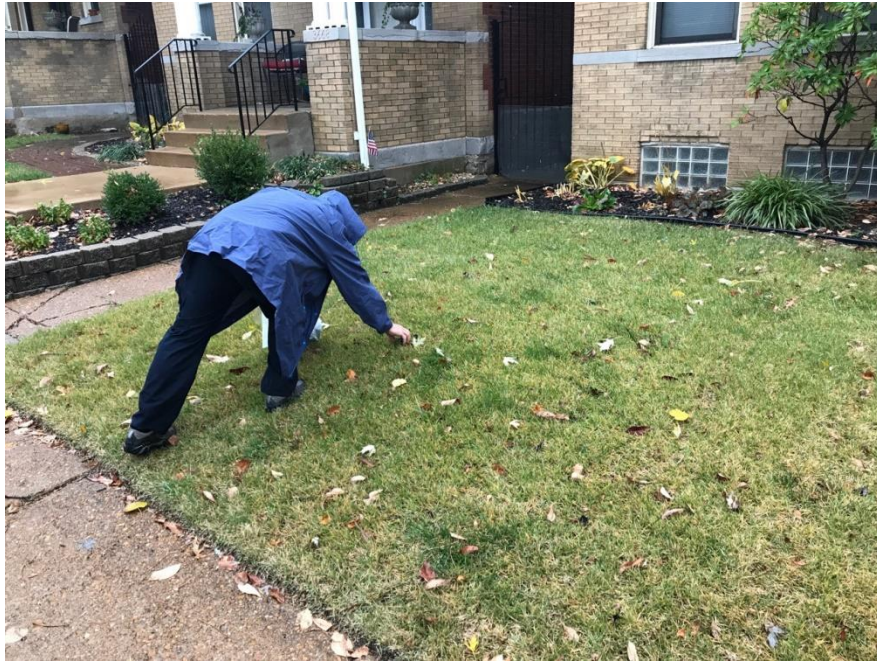
Photo No.: 83	Date: 11/18/2017	Time: 10:20
Photographer: Greg Blattner		Direction: Southeast
Latitude: 38.61913	Longitude: -90.24159	
Description: This photograph shows debris sample WF-T1-026 collected from residential neighborhood near Park Warehouse.

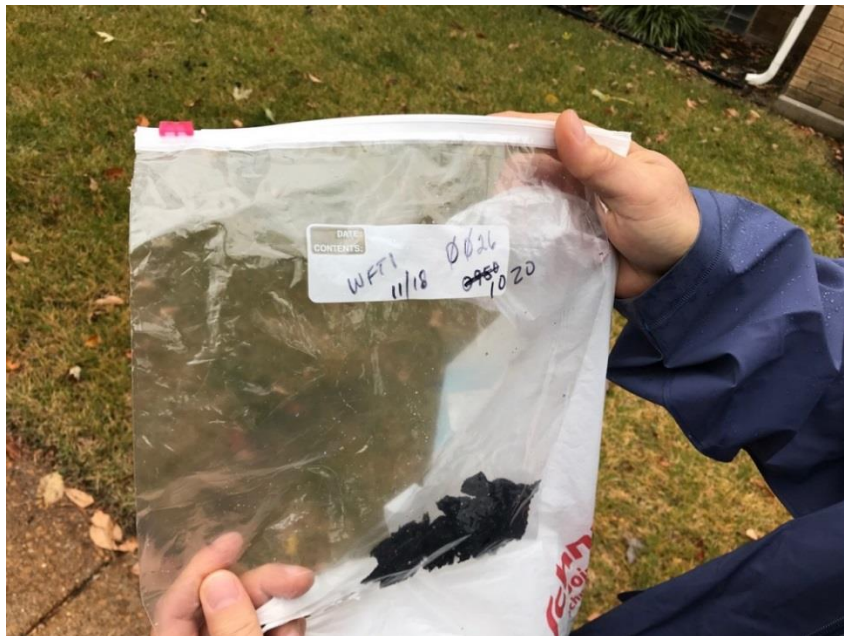
Photo No.: 84	Date: 11/18/2017	Time: 10:20
Photographer: Greg Blattner		Direction: Southeast
Latitude: 38.61913		Longitude: -90.24159
Description: This photograph shows debris sample WF-T1-026 collected from residential neighborhood near Park Warehouse.

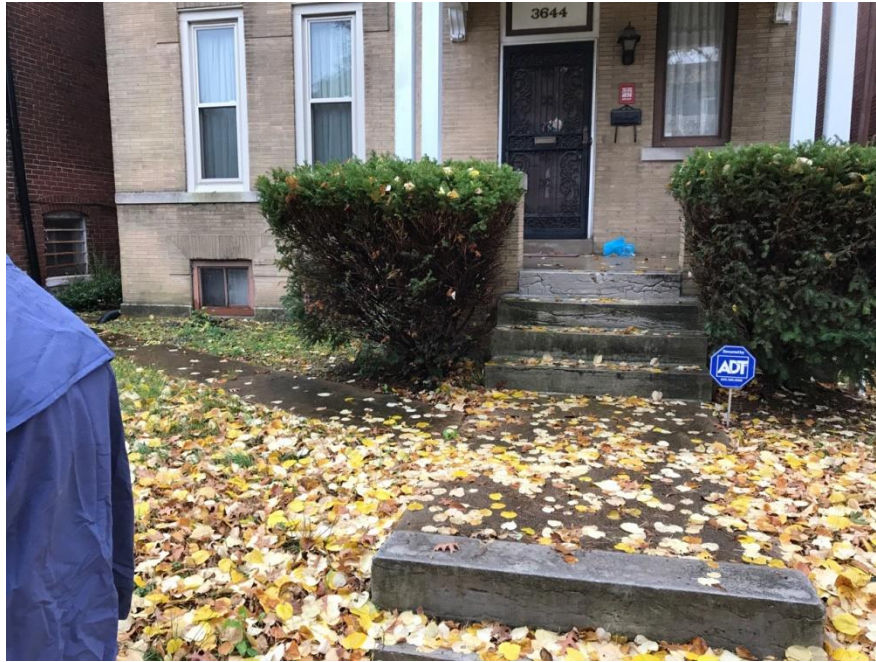
Photo No.: 85	Date: 11/18/2017	Time: 10:28
Photographer: Greg Blattner		Direction: South
Latitude: 38.61907		Longitude: -90.24065
Description: This photograph shows debris sample WF-T1-027 collected from residential neighborhood near Park Warehouse.

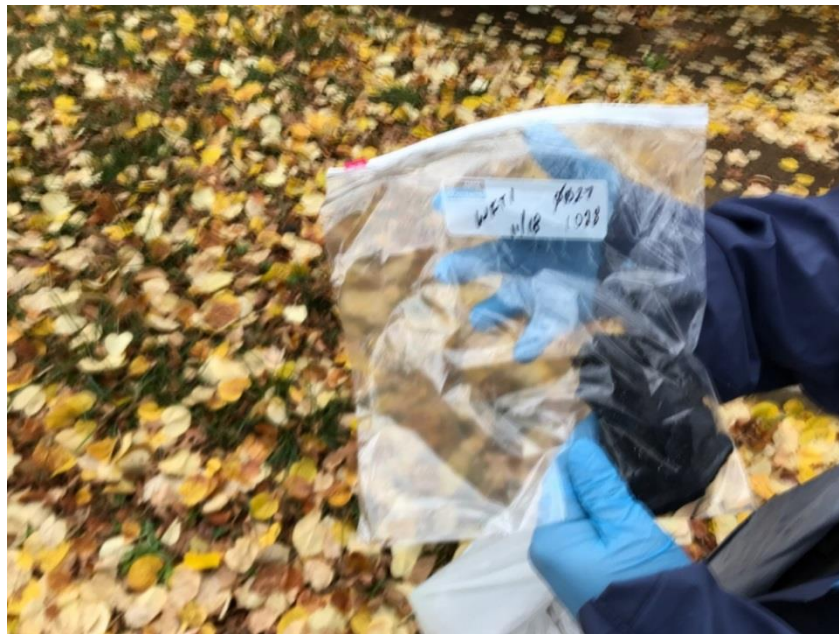
Photo No.: 86	Date: 11/18/2017	Time: 10:28
Photographer: Greg Blattner		Direction: South
Latitude: 38.61907	Longitude: -90.24065	
Description: This photograph shows debris sample WF-T1-027 collected from residential neighborhood near Park Warehouse.
